# Opel Astra J - Airbag indicator lamp lights up | HELLA

Astra J

Model year: 2010 - 2012

## Airbag indicator lamp lights up

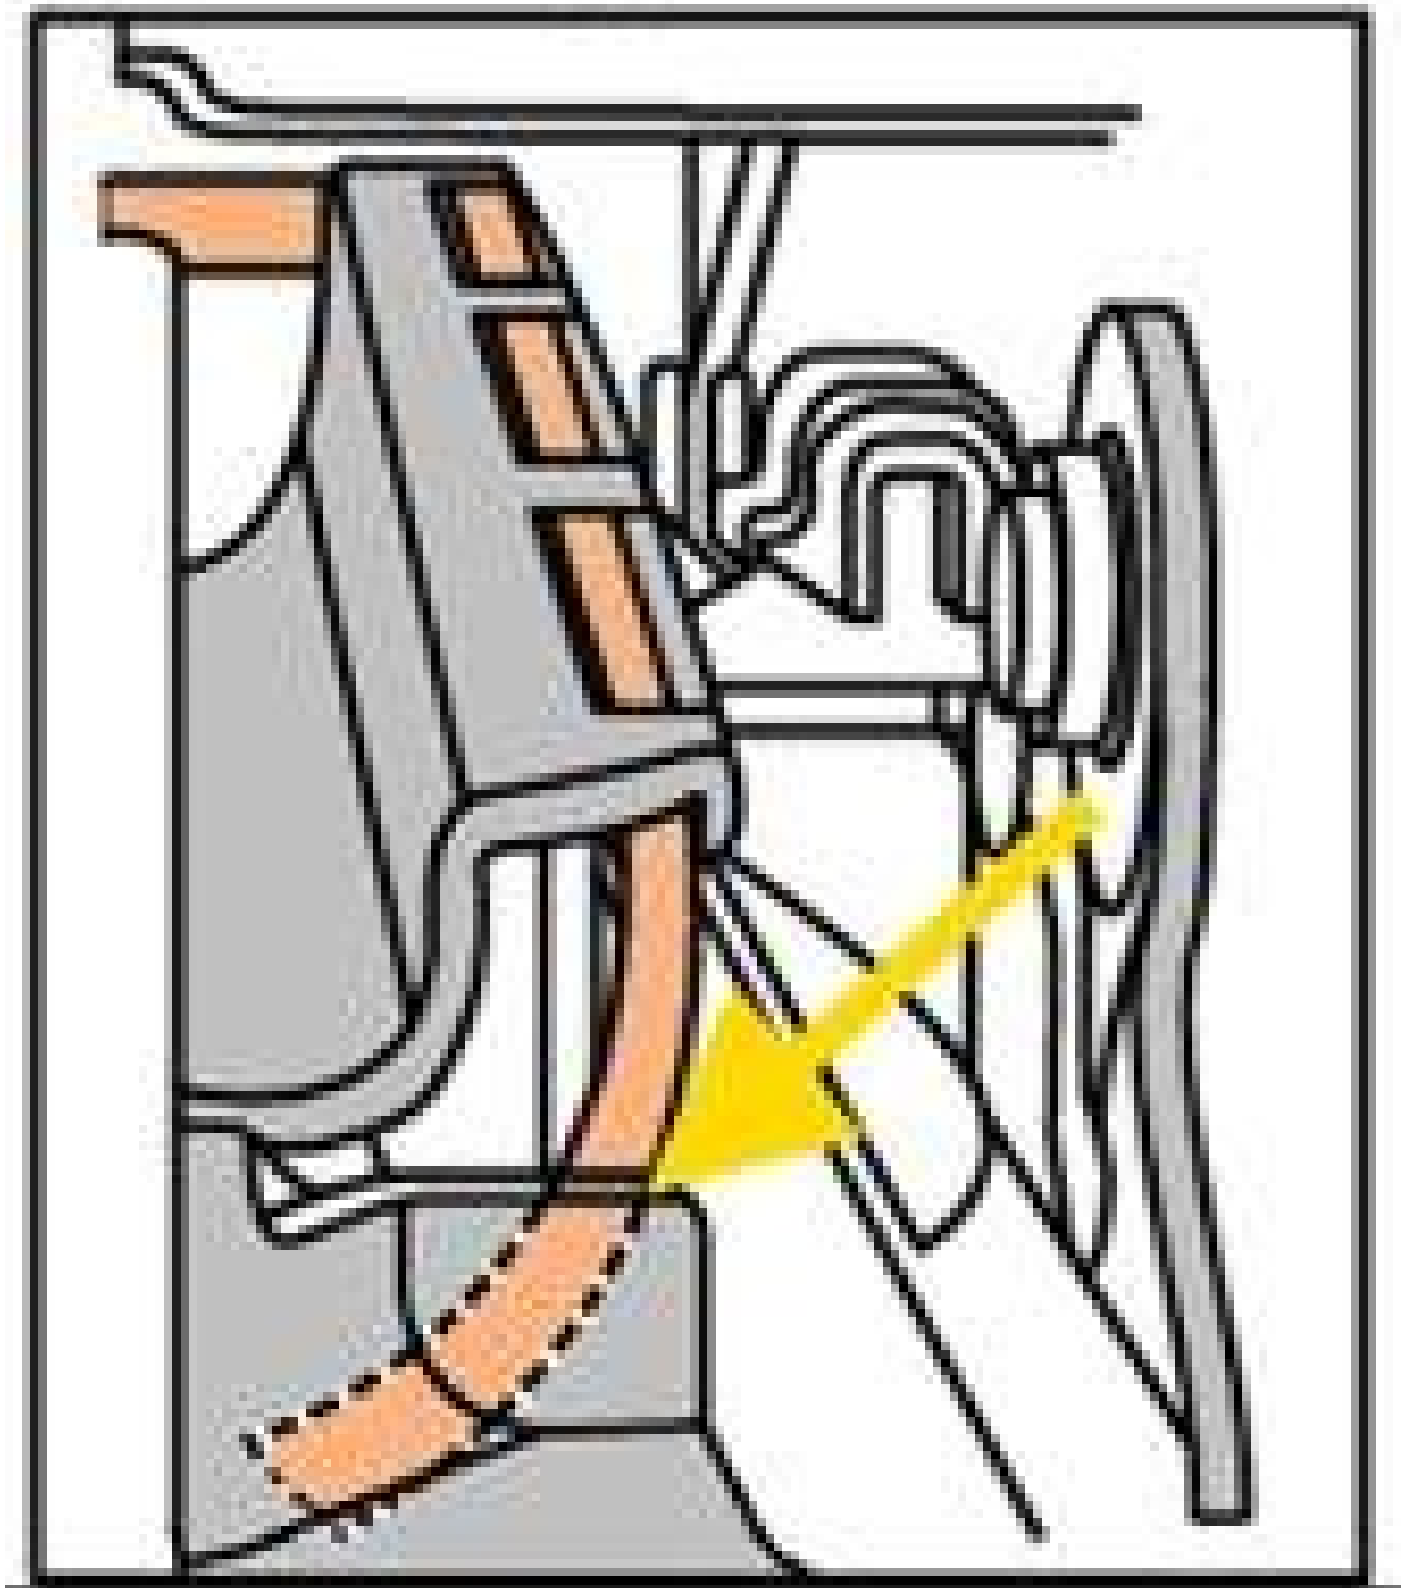
Figure 1

A possible cause could be a damaged cable strand in the airbag system (in the area of the rail system of the front seat adjustment).

Check the cable strand for damage. In doing so, check in particular for signs of abrasion.

If a cable strand is laid incorrectly (marked in figure 1), it may be damaged.

- Replacing the belt tensioner unit
- Re-installation and fastening of the cable strand
