# **Opel Zafira A - Fluctuating instrument display | HELLA**

**Model years: 2002 to 2005**

## **Fluctuating instrument display.**

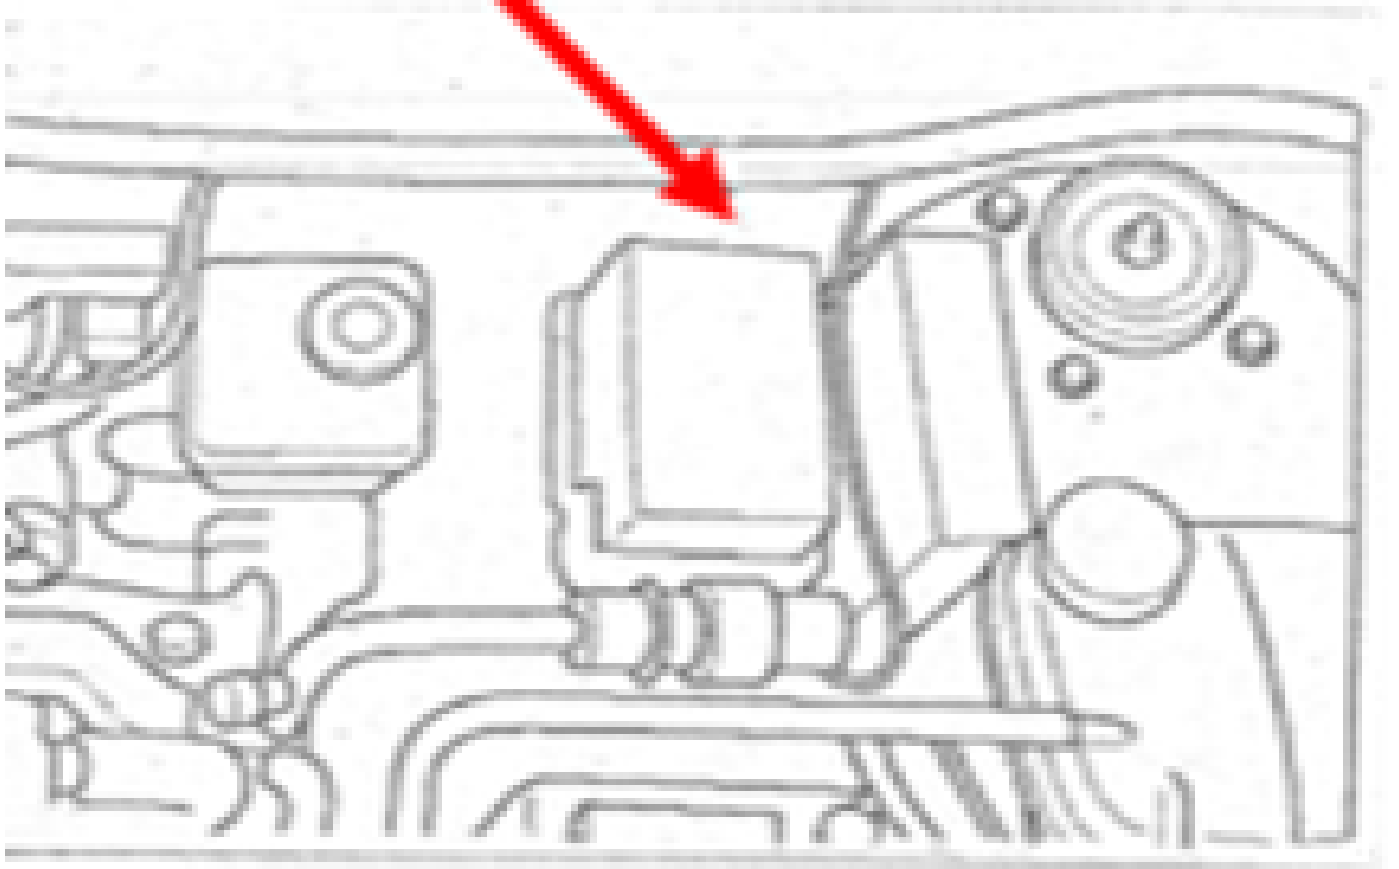
If there are complaints for these vehicles about the problems mentioned above, a possible cause could be water ingress at the intersection of the cable harness connection that is located near the splash wall (see figure).

In this situation, disconnect the battery before repairing the cable harness and then:

- Visually inspect the connector pins of the cable harness multi-plug.
- Clean the connector pins with a suitable contact spray, or replace them if necessary.
- Check the connector halves for damage and for proper connection.
- Reconnect the cable harness multi-plug.
