## Porsche 911 (991): radiator fan error message

Data sheet	
Manufacturer	Porsche
Vehicle model	911 (991)
Engine	All models
Model year	2011 - 05.2016
Symptoms	Error message: "Radiator fan error, avoid full engine load, you may continue driving"

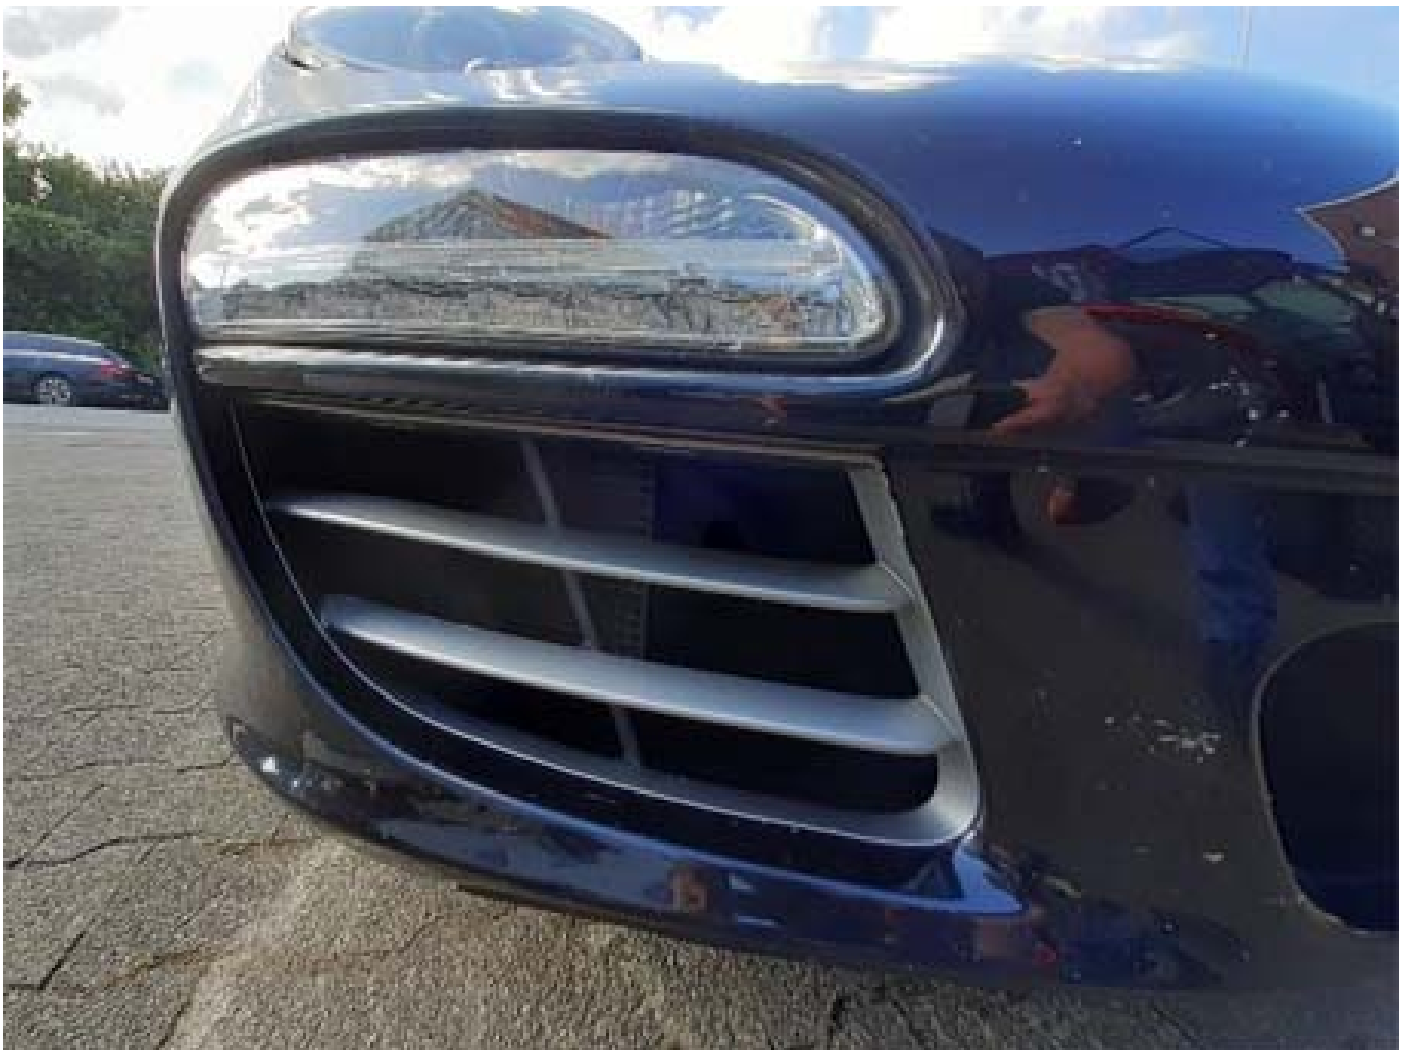
Figure 1: The radiators are located on the left and right behind the air guide grille in the bumper.

The radiators are located on the left and right behind the air guide grille in the bumper ([Figure 1](#)). The fans themselves can be accessed from the wheel well if the wheel well trim ([Picture 2](#)) is removed first.

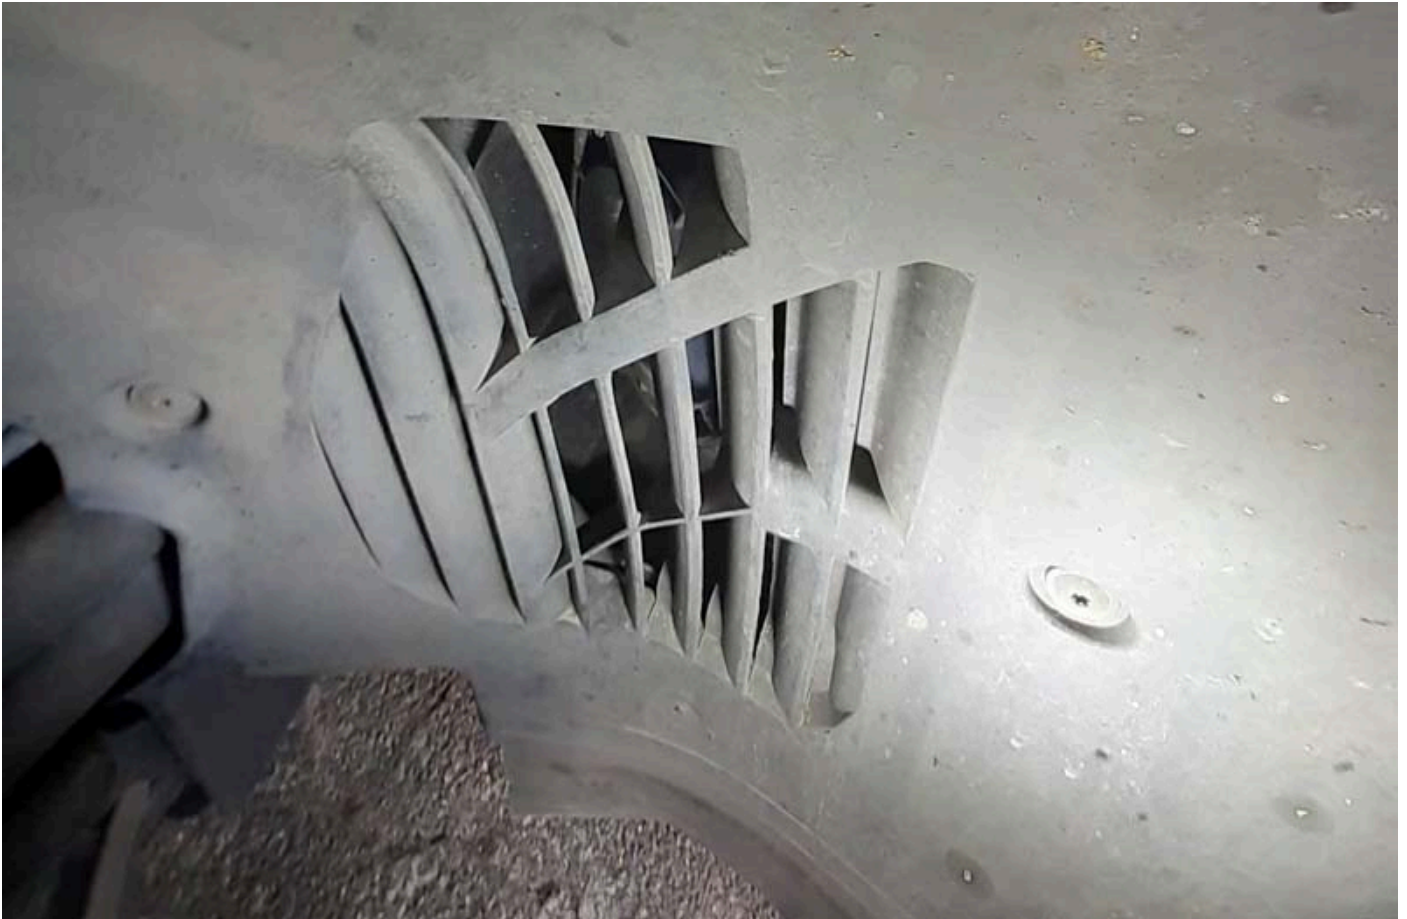
Figure 2: The fans can be accessed from the wheel well if the wheel well trim is removed first.

Check the wiring on both fans as well as the fans themselves for penetrated moisture to resolve the situation. If there is corrosion on the connectors, for example, this is a clear indication of the

cause of the error message. It is then necessary to clean the connections and, if necessary, repair them. The radiator fan may also need to be replaced.
