## Subaru XV - booming noises from the rear of the vehicle

Data sheet	
Manufacturer	Subaru
Vehicle model	XV
Year of manufacture	From 2017 onwards
Engine	All models
Symptoms	Booming noises from the rear of the vehicle

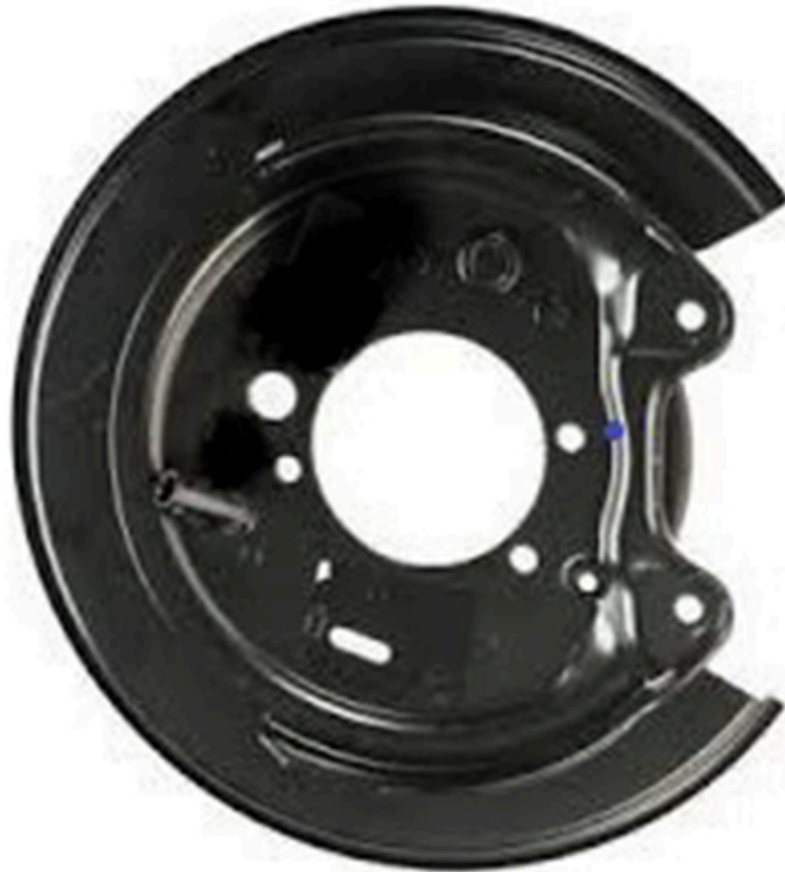
If loud, booming noises are heard from the rear of the vehicle, defective rear wheel bearings may be the cause.

The rear wheel bearings may have been damaged by a design-related malfunction of the rear wheel brakes during assembly.

In order to remedy this, not only new wheel hubs but also modified backing plates (picture) for the rear brake have to be installed.

When assembling, please observe the vehicle manufacturer's specifications.
