## **Fiat Stilo** **All vehicles**

### **Airbag light illuminates**

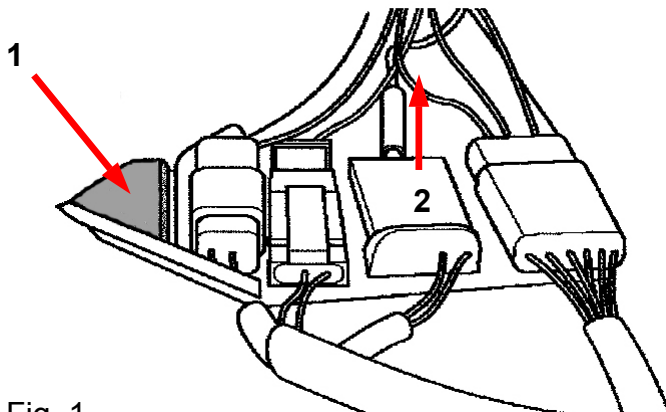
Fig. 1

If there are complaints about the above-mentioned fault, the cause could be defective plug-connections on the airbag/safety-belt cable loom. These are located under the driver seat. In this case, proceed as follows:

- Disconnect the battery.
- Remove the holder for the plug-connections (see Fig. 1, Item 1).
- With the aid of a small screwdriver, lever the plug-connection of the airbag cable loom out of the holder (see Fig. 1, Item 2).
- Feed cable clips through the holder of the plug-connection (see Fig. 2).
- Wrap insulating tape around the plug-connection, such that both plug ends are fixed to one another.
- After this, fasten the plug-connection with the cable clip onto the holder (see Fig. 3).
- Refit the holder under the driver seat, connect the battery and delete the fault memory.
