Mercedes W124

Radio is not working

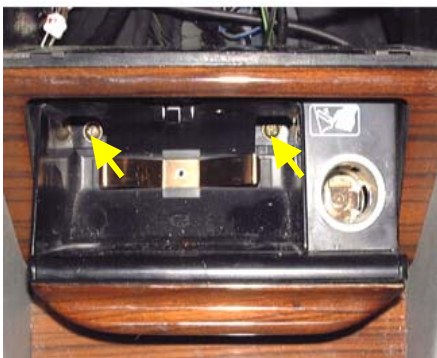
Fig. 1

- Remove the ash tray insert
- Loosen the ash tray base by loosening the two screws (Fig. 1)
- Take the decorative strip off
- Remove the ash tray base and the cigarette lighter
- Check the cable connection on the cigarette lighter and repair if necessary (Fig. 2)
- Check the radio function

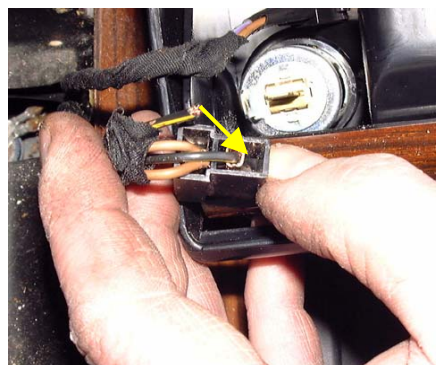
Fig. 2

Since the current supply (switched Plus = terminal 15) of the radio is tapped separately from the cigarette lighter and this connection is prone to tear off (Fig. 2), a visual/functional test of the fuse or the cigarette lighter alone is not enough to recognize the fault.
