Lexus LS 400 (UCF20) Model year: 1994–2001

VSC lamp lights up / VSC without function

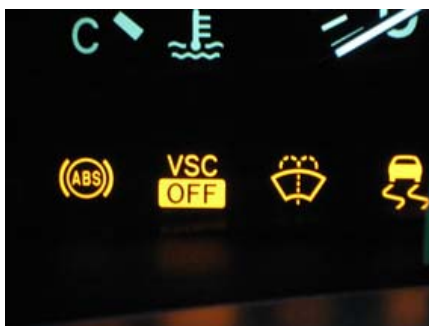
Fig. 1

With the above-mentioned vehicles, the control light for the electronic stability program (VSC OFF, fig. 1) can be permanently lit after the battery has been replaced. In addition, the VSC/ESP cannot be activated by pressing the switch (fig. 2). The VSC/ESP is not activated by driving routine either.

To remedy the situation, the ground connection should be disconnected from the battery again for a few minutes and then re-connected. In many cases, the VSC/ESP control light goes out again after this and deactivation/activation via the switch is possible again.
