Mercedes-Benz Type 170 (SLK) 202 (C-Class) 208 (CLK) 210 (E-Class) with automatic transmission

Selector lever is blocked.

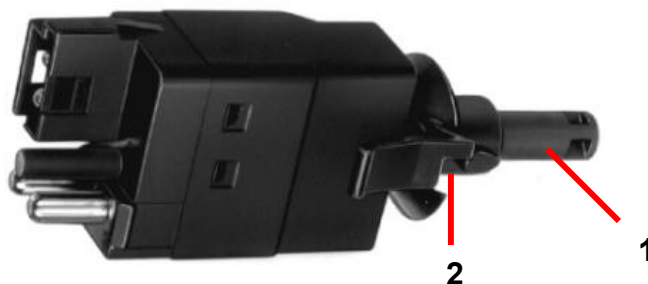
- Pull the activating pin (1) of the brake light switch out completely.
- Press the brake pedal right down.
- Insert the brake light switch in the holder and turn until the catch (2) locks in place.
- Release the brake pedal. The activation path is set automatically.

If there are complaints with these vehicle types that the selector lever cannot be moved from the park position (despite the brake pedal being pressed), one possible cause is the brake light switch. In this case the selector lever module does not receive a signal from the brake light switch. There is no fault stored in the fault memory of the selector lever module. To eliminate the fault the brake light switch has to be replaced. To do this proceed as follows:

- Remove the trim below the steering wheel.
- Disconnect the plug from the brake light switch.
- Turn the brake light switch and pull it out.
