Opel Vectra B Model year 1999 - 2002

Airbag warning lamp illuminates.

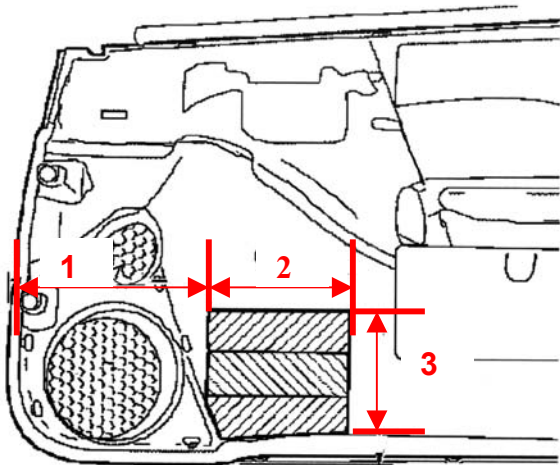
Inside view of the door trim panel

1 = 240 mm
2 = 150 mm
3 = 170 mm

- Remove the door trim panel.
- Attach insulation in 3 strips (each overlapping by approx. 2 mm) at the spot marked (see illustration).
- Refit the door trim panel.
- Delete the fault memory and make sure the airbag warning lamp has gone out.
