# BULLETIN

## Vauxhall

### Astra J

### Airbag indicator lamp lights up

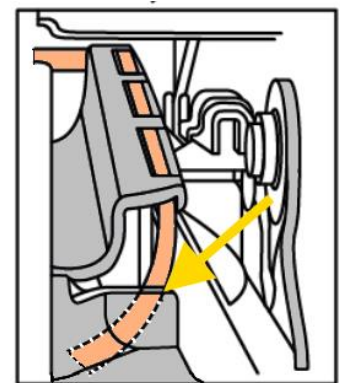
Figure 1

A possible cause could be a damaged cable strand in the airbag system (in the area of the rail system of the front seat adjustment).

If a cable strand is laid incorrectly (marked in figure 1), it may be damaged.

Check the cable strand for damage. In doing so, check in particular for signs of abrasion.
