VW

Golf 3, Passat 35i (3A)

With anti-theft alarm system

Engine will not start / cuts out

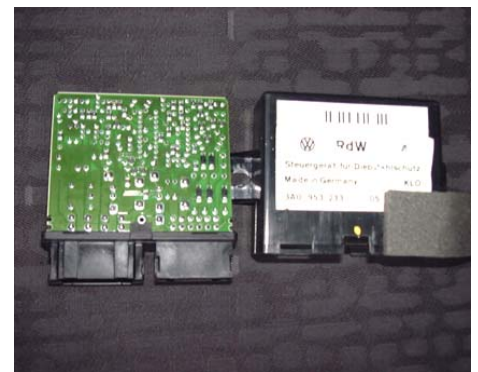
The cause of this is often a faulty anti-theft alarm system control unit (see picture). This is in the footwell on the driver's side. If the control unit is disassembled, faulty solder joints or burnt out circuit-board conductors can be seen on the printed circuit board. Solder joints that have been loosened due to vibration can be re-soldered without any problems. In the case of burnt out circuit-board conductors the control unit should be replaced and the wiring should be checked.
