VW Golf III build year from 1991 to 1999 Headlamp-retrofit

Retrofit from the standard to the GT/GTI/VR6 version.

Bulletin

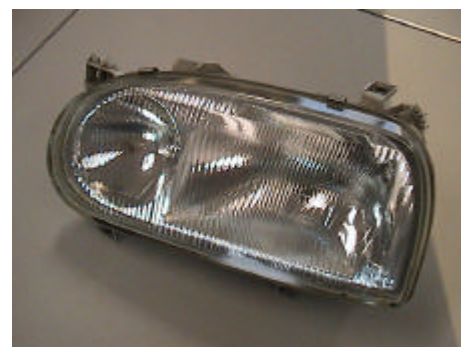
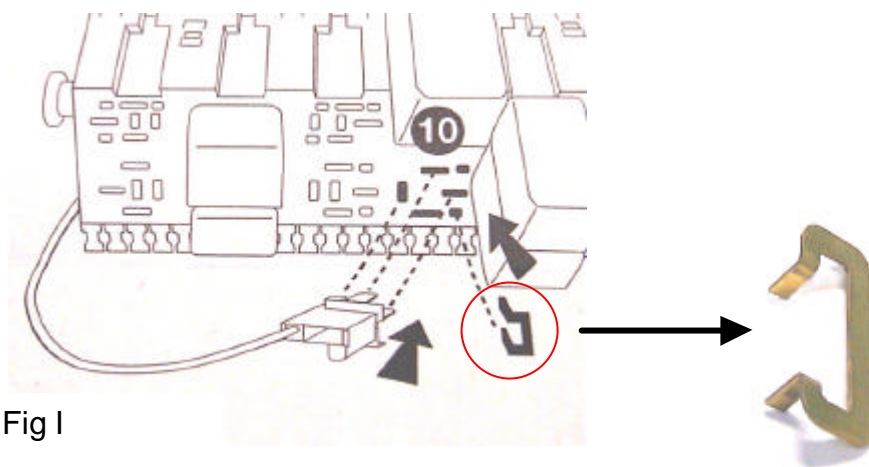
Fig I

If the vehicle is equipped with factory fitted fog lamps, remove plug or relay, fit the contact bridge (bridge pins 3 and 4) and refit plug or relay. (Fig I)

When carrying out a headlamp-retrofit on the request of a customer ensure during installation, that the bridge contact is fitted to connector 10 in the fuse box.

This contact bridge is absolutely necessary, otherwise when The main beam is switched on, the dip lights go out.

Due to the dip- and main beam being produced by two different reflectors, the non operation of the dip light would create a very dark area on the road in front of the vehicle, this of course being dangerous.
