Opel Astra G All Models as of Model Year 1999

Noises From Area of Interior Lamp

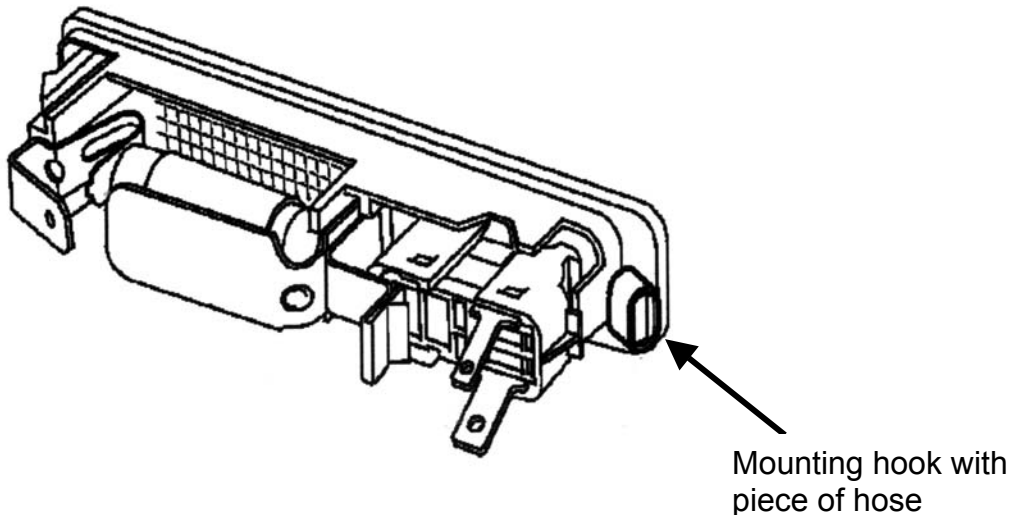
If complaints are received on these vehicles that noises can be heard from the area of the interior lamp, the interior lamp may be the cause. Too much play between the mounting opening and mounting hooks on the interior lamp allow it to rattle against the handle. To eliminate this rattling, proceed as follows:

- Remove interior lamps.
- Cut off an approx. 3 mm long piece of windshield washer hose.
- Slide the piece of hose over the mounting hooks on the interior lamp.
- Install interior lamp and check whether it is tight.
